# NORTH WALES BOROUGH

MONTGOMERY COUNTY, PENNSYLVANIA

## WALKABILITY AUDIT REPORT

September 2021

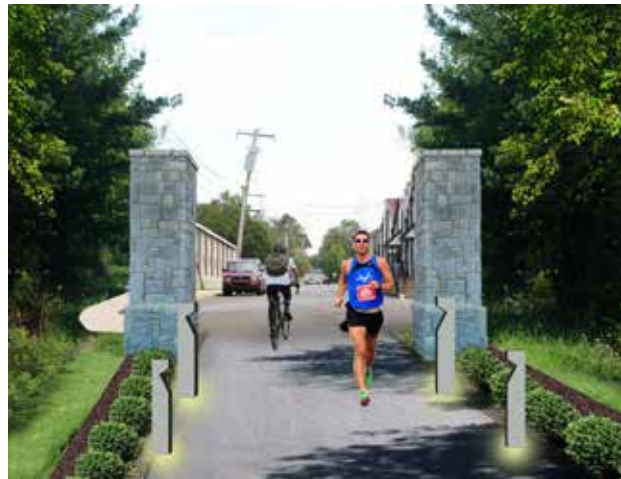
Rendering of the Center Street/Parkside Place Park Gateway

In 2020, the Borough was awarded a \$154,725 grant from Montgomery County Planning Commission's *MontCo 2040* Implementation grant program. The goal of this grant program is to implement the goals and objectives identified in *MontCo 2040*, the County's 2015 Comprehensive Plan. The Borough intends to install new sidewalks, crosswalks, and ADA ramps on Center Street between Walnut Street and the trail connection to Parkside Place Park in Upper Gwynedd Township. As part of the project, a rectangular rapid flashing beacon is proposed for pedestrians to cross the north leg for Walnut Street (SR 2010) at its intersection with Center Street. The flashing beacon will be equipped with accessible pedestrian signals (APS). A new gateway entrance, with lighting and signage at the trailhead, will be installed to formalize the trail entryway and provide direction to recreational amenities, including the regional Green Ribbon Trail. This project will improve pedestrian connectivity, safety, and visibility at a key connection between the two communities. The total project is anticipated to cost \$194,670.

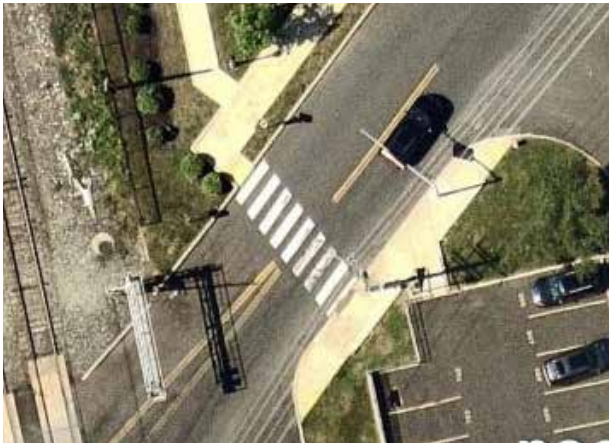
A highly visible crosswalk across Beaver Street  
Source: NearMap, captured March 5, 2021

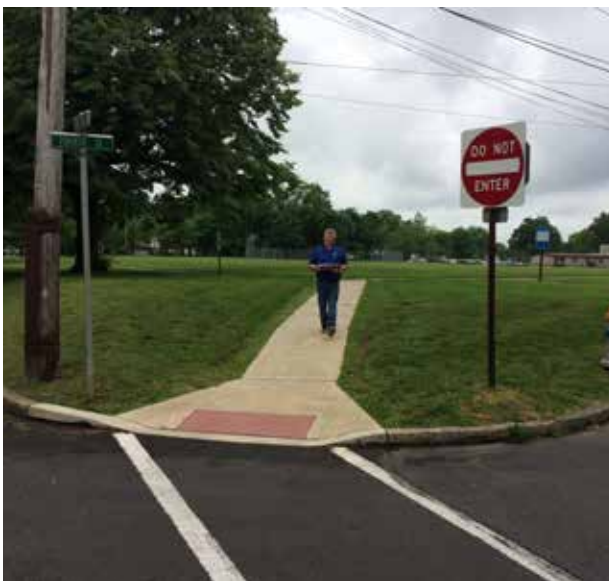
ADA ramp with DWP by North Wales Elementary School

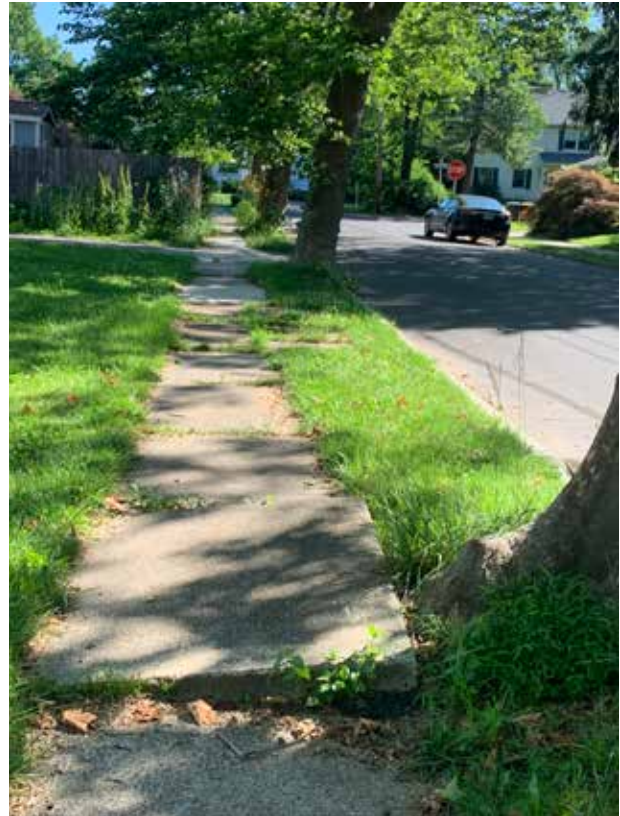
A poor condition sidewalk with severely uplifted blocks

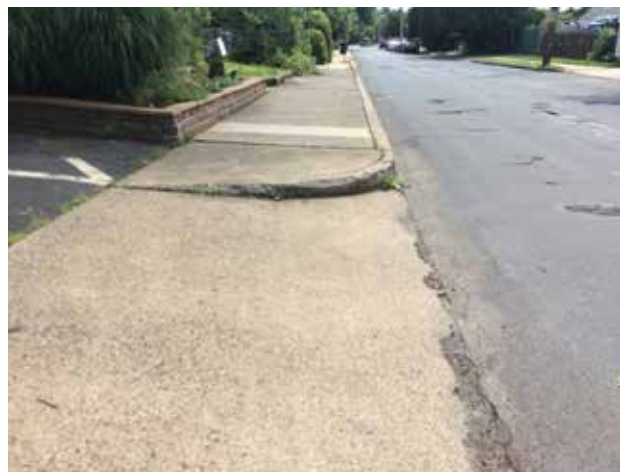
A sidewalk with an abrupt bump at a driveway

When poorly designed, driveways can act as barrier to pedestrians enjoying the sidewalk. Some driveways have a curb that drops without a ramp, some that are designed to connect to the sidewalk have harsh slopes, and others remain flat and comfortable for users. If driveways acted as a barrier to a pedestrian, then it received 0 points. If sidewalks remained flat at driveways, then 1 point was awarded.

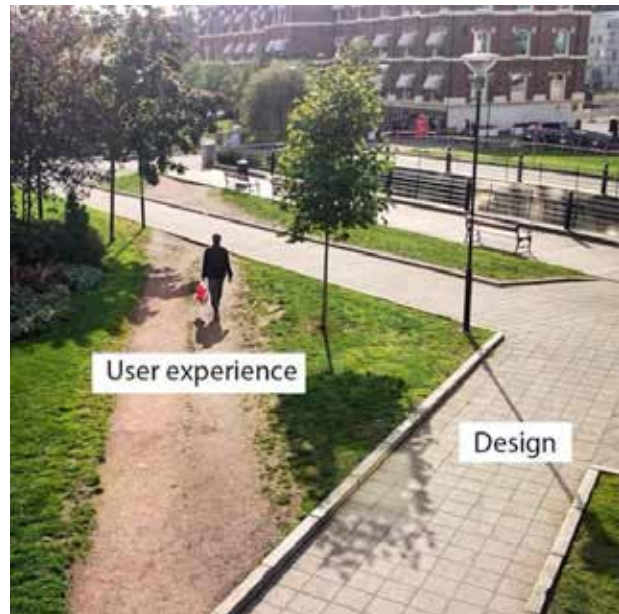
Desire lines or desire paths are areas that pedestrians use regardless of the fact that there is no infrastructure for them. During the walk audit, these were seen on a handful of streets that lacked sidewalks or had partial sidewalks. If desire lines were present, then 0 points were awarded. All segments lacking desire lines received 0.5 points.

Desire lines vs. existing infrastructure  
Source: 99% Invisible

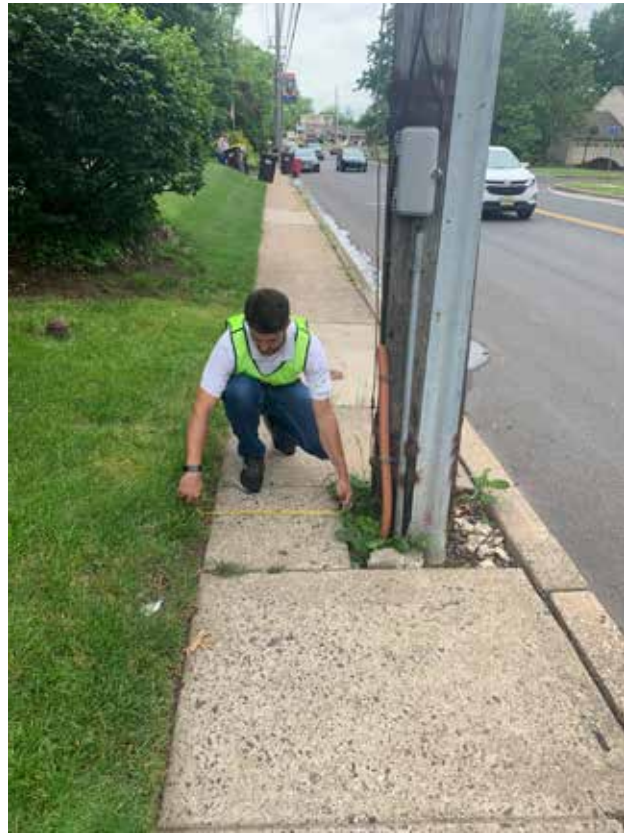
Alan Guzzardo, Assistant Borough Manager, measuring sidewalk width on Beaver Street on June 4, 2021

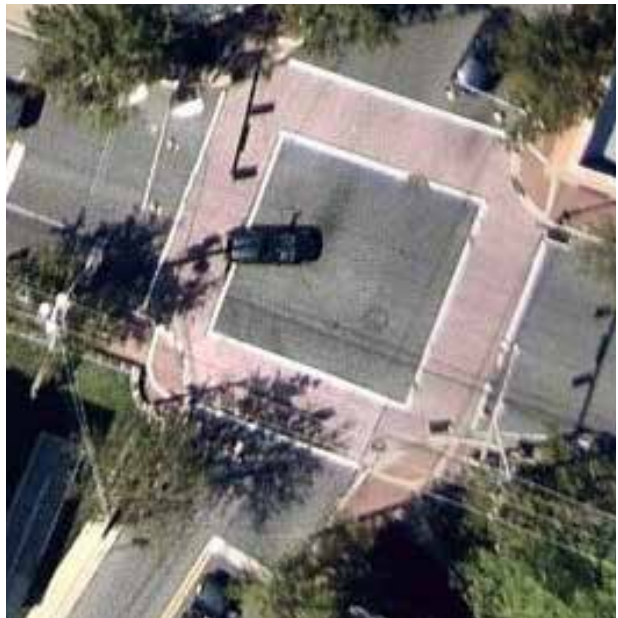
NearMap imagery of the intersection of Main and Walnut Streets, June 5, 2021

used for this report was collected on March 5, 2021, but previous dates were also used throughout this process. This process was utilized to quickly scan the Borough and note all streets that were lacking sidewalks altogether, which were generally not walked by staff. Thanks to the high accuracy of the imagery, certain intersections were also inventoried using a combination of NearMap and Google Maps.

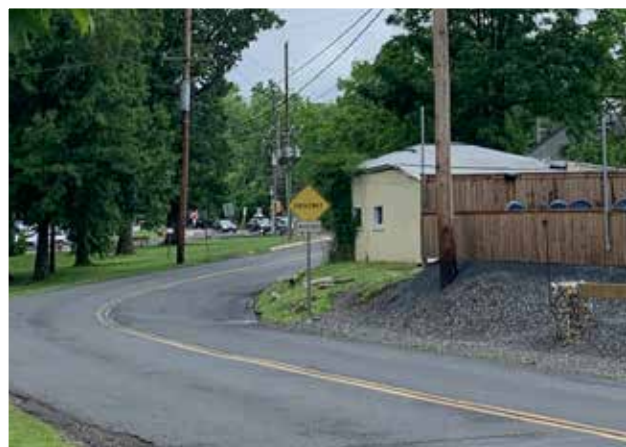
Beaver Street, a high traffic collector street, lacks large sections of sidewalk between 4<sup>th</sup> Street and Walnut Street. To make matters worse, there is a blind curve in Beaver Street which puts pedestrians walking

A blind curve on Beaver Street between 6th and Walnut Streets

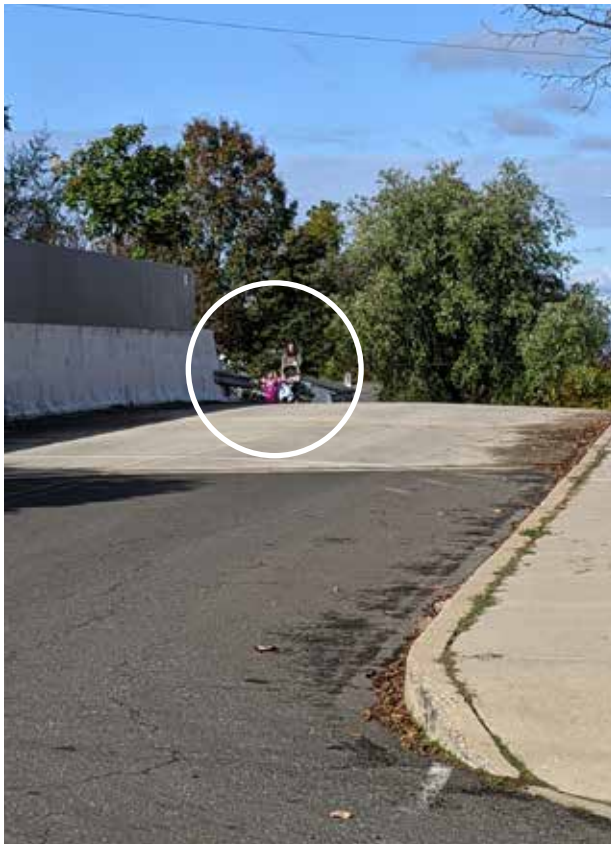
A family walking in the road on the Pennsylvania Ave bridge

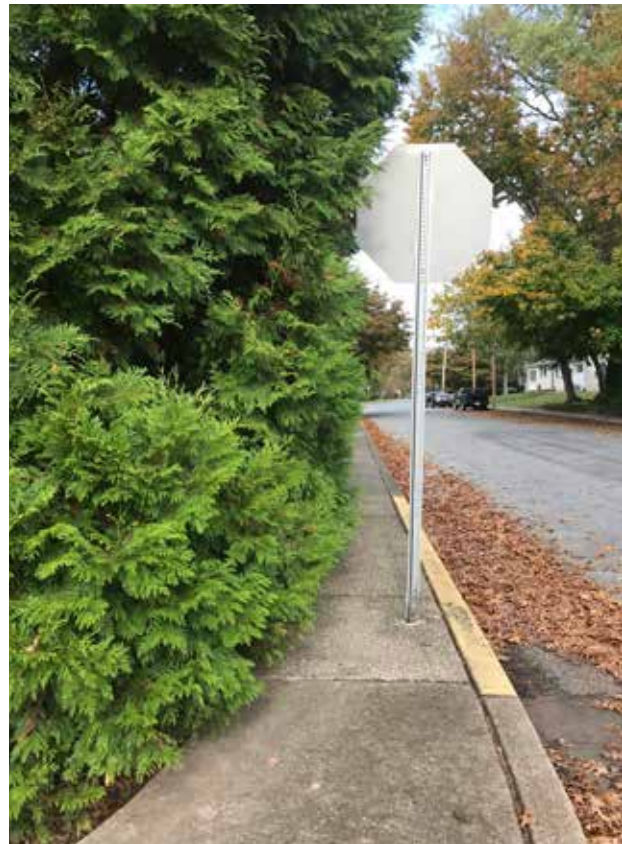
Perhaps the most rampant challenge to using sidewalks in the Borough is the presence of obstacles in the pathway. Obstacles in the sidewalk have the effect of narrowing the width of the usable sidewalk at certain points, which can prevent those in wheelchairs from enjoying use of the sidewalk altogether. These obstacles come in many forms, but the most prevalent offenders were garbage cans (which were not always counted as 'obstacles' in scoring, because they are temporary), overgrown vegetation, and street signs. Overgrown vegetation can be remedied by having Borough code enforcement officials notify property owners that it is their responsibility to keep the sidewalk clear of obstructions. This can be a daunting task, especially when it is such a widespread issue, however an education campaign could make this an easier task to accomplish. Policy options will be offered in Chapter 8, Implementation.

A sidewalk with overgrown vegetation that impedes walking

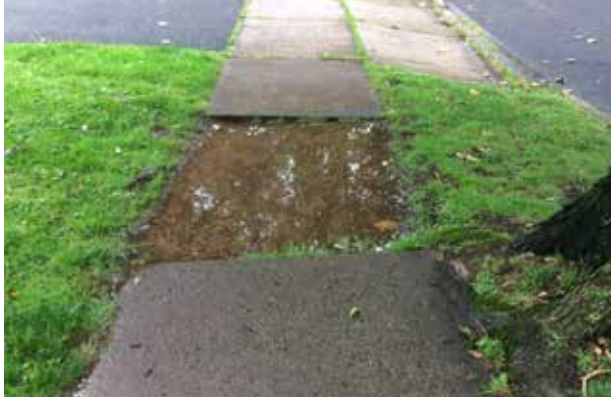
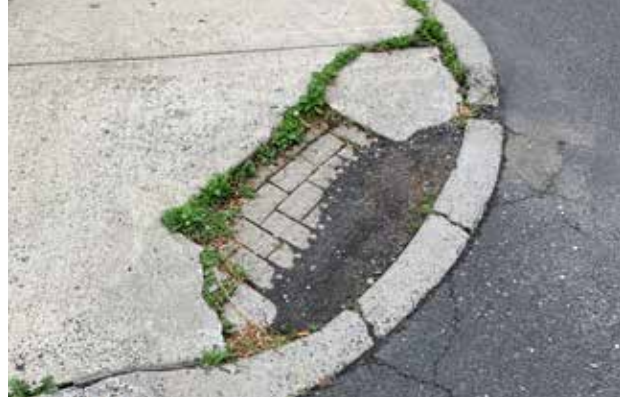
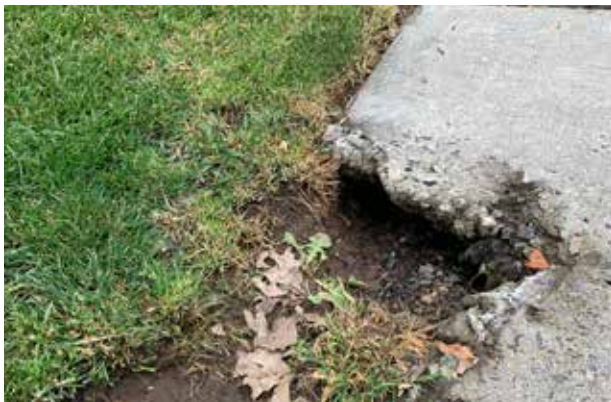
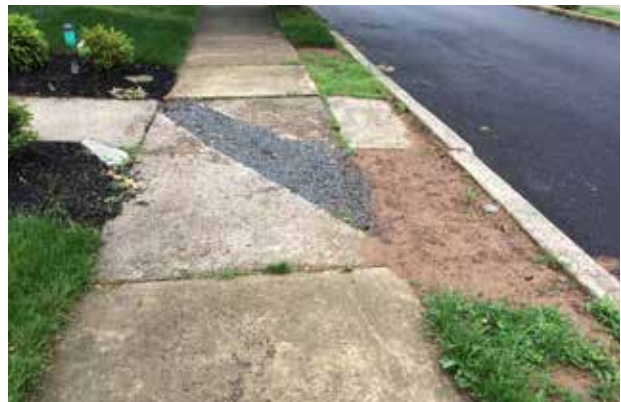
Sidewalks in various states of disrepair throughout the Borough

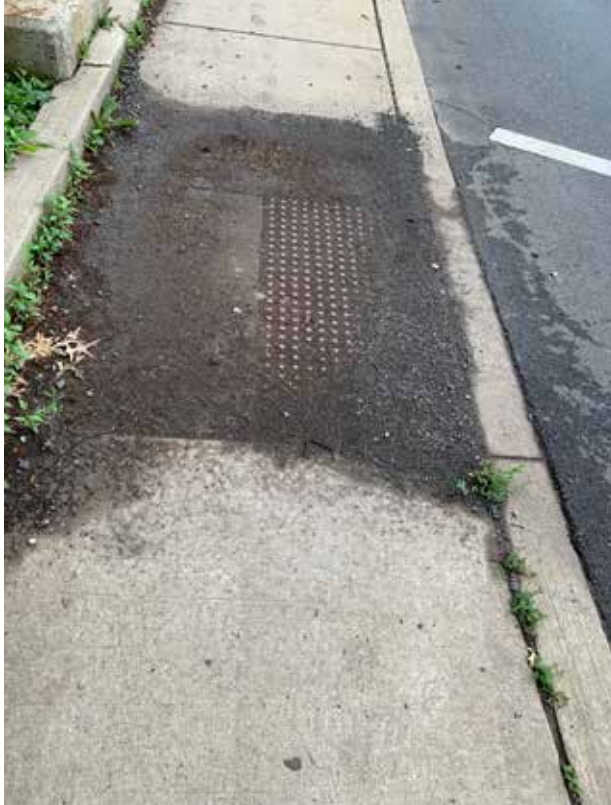
warrants additional caution. DWPs are missing from many existing curb ramps.

A curb ramp and DWP in need of maintenance

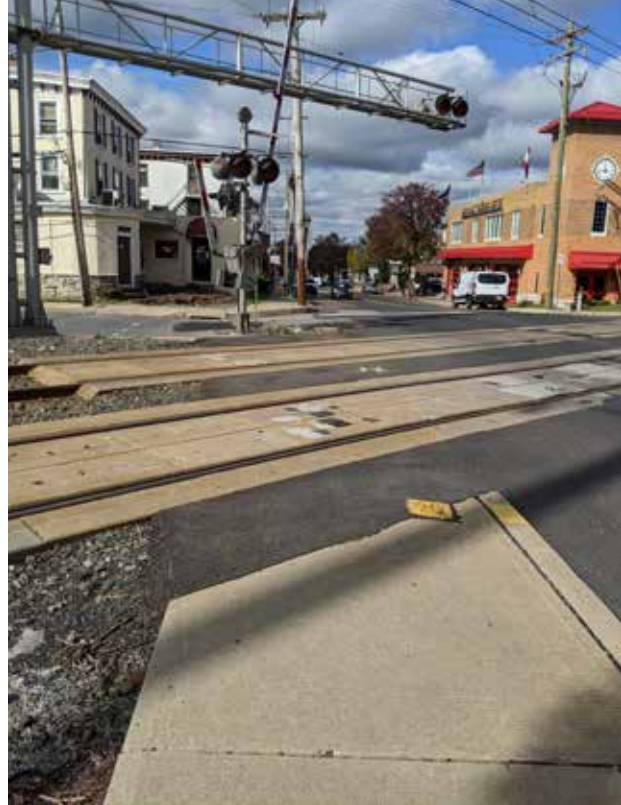
Railroad crossing at Main St & Montgomery Ave

The railroad crossing at Main and Montgomery Streets will be explored in detail as a study area in Chapter 7, Focus Areas. We'll discuss potential upgrades that could be utilized to increase pedestrian's actual and perceived safety at these crossings.

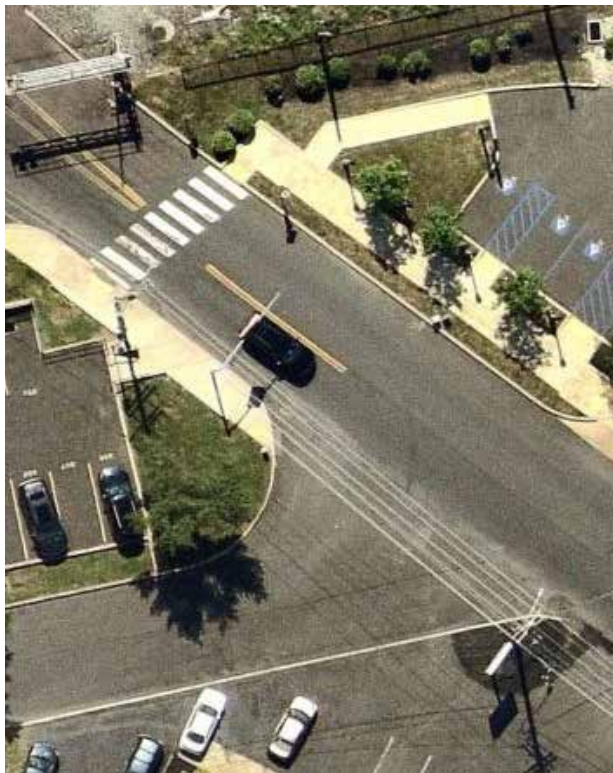
The sidewalk along the SEPTA-owned train station parking lot on Beaver Street is both beautiful and highly usable for pedestrians. There is ample landscaping to both separate the user from the street and the parking lot, sidewalks are 8 feet wide, there are attractive street lamps, and there are highly visible crosswalks across both Beaver Street and at the entrance to the parking area. The sidewalk and streetscape design generally meet the recommendations from *Walk MontCo*. The highly visible crosswalk makes for a safer route to connect those who are parking to the train boarding platform.

The sidewalk along the municipal parking lot on Beaver Street is a prime example of a well-designed sidewalk and streetscape. NearMap June 5, 2021

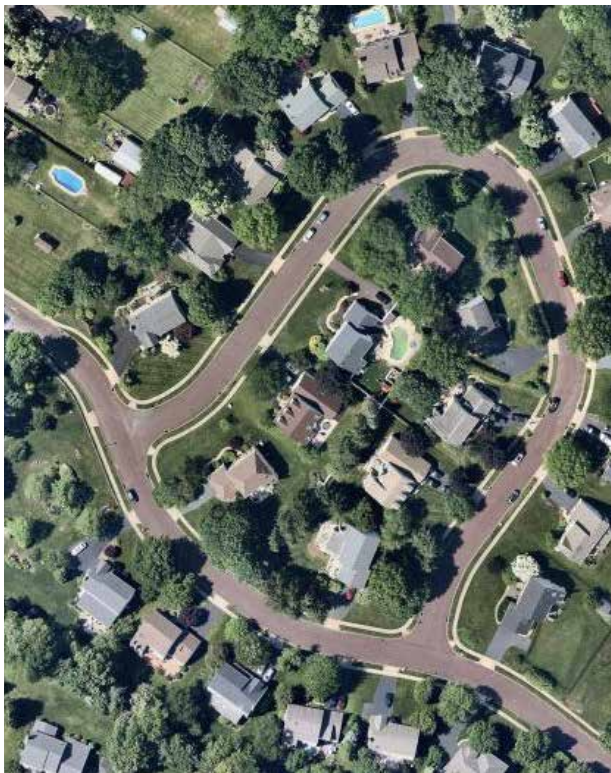
The development of Windsor Way included excellent pedestrian facilities that make for a walkable neighborhood. NearMap June 5, 2021.

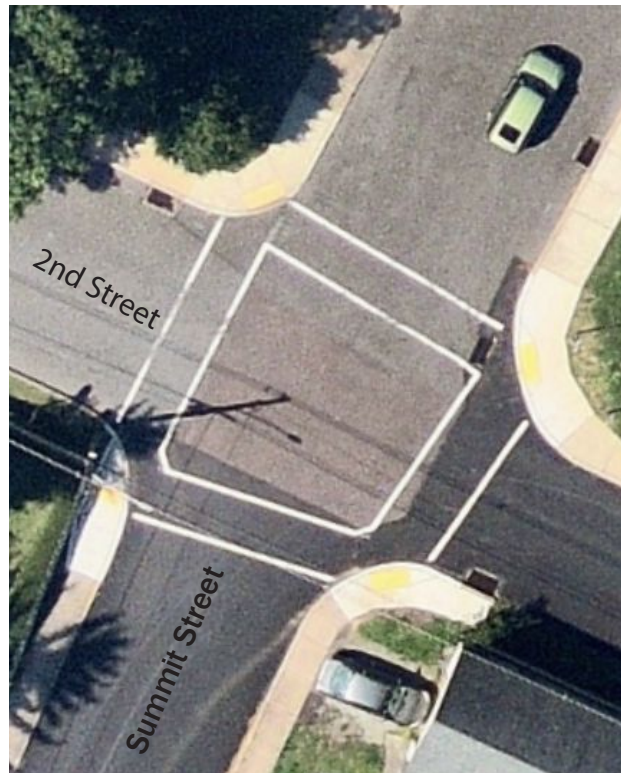
from school. The intersection was redone as part of the Safe Routes to School grant project. The improvements included new curb ramps with yellow detectable warning plates on all four corners. Segments of sidewalk were also redone to complement the intersection improvement. Although crosswalks were painted along all sides, a high visibility crosswalk would be more appropriate given how important student safety is. This area will be part of a focus area in Chapter 7. There is, of course, a glaring deficiency at this intersection: the missing sidewalk on the south side of 2nd Street. Both of the blocks between Church and Summit Streets and Summit Street and Prospect Avenue are lacking sidewalks. Missing sidewalks throughout the Borough should be systematically installed, but this may be a priority area, given the proximity to the elementary school. This will be discussed in subsequent chapters.

Summit & 2nd St, NearMap June 5, 2021

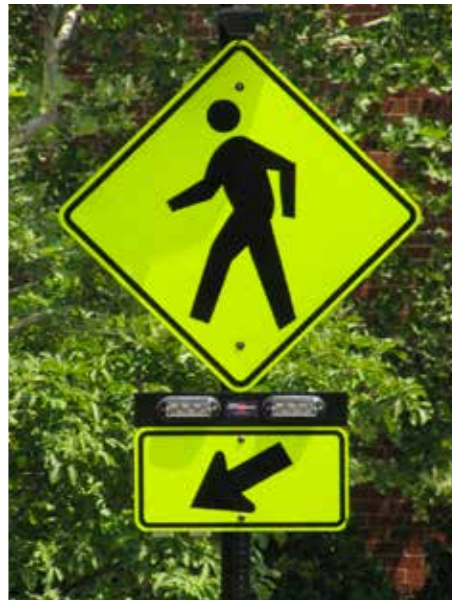
2. **Crosswalk Visibility Enhancements.** Improving and enhancing crosswalk lighting, signage and markings draws attention to pedestrians and can help pedestrians identify safe crossings. Enhancements may include high visibility markings of crosswalks, parking restrictions near crosswalks, advanced “stop” or “yield” markings, signs and curb bumpouts/extensions. Visibility enhancements can reduce crashes by 23-48%.

Rectangular Rapid Flashing Beacon  
Source: Carol Kachadoorian (2012)

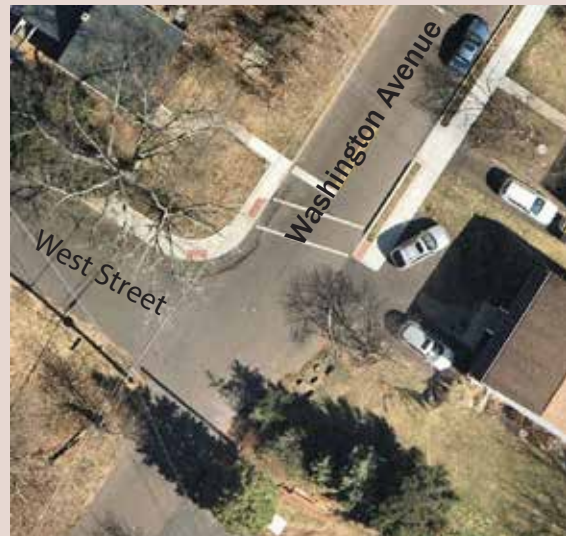
#### Washington Avenue & West Street 30.75 out of 35 points

- Full points for presence of a good condition crosswalk, but lost 1.5 points for having a standard crosswalk vs. high-visibility style.
- Lost 1.25 points for lacking curb ramps on all corners, however there are no sidewalks to connect to. DWPs present on all existing ramps.
- Stop signs on all streets.
- Within ½ mile of the business district and ¼ mile

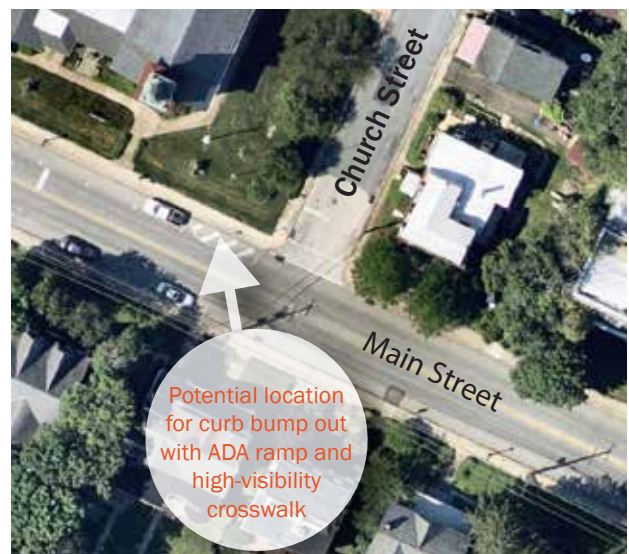
NearMap, June 5, 2021

These two intersections are explored in-depth in Chapter 7, Focus Areas. Briefly, curb bumpouts may be feasible at one or both intersections and crosswalks are sorely needed. Both sides of the street

also have SEPTA bus stops, which adds another dimension to pedestrian safety concerns.

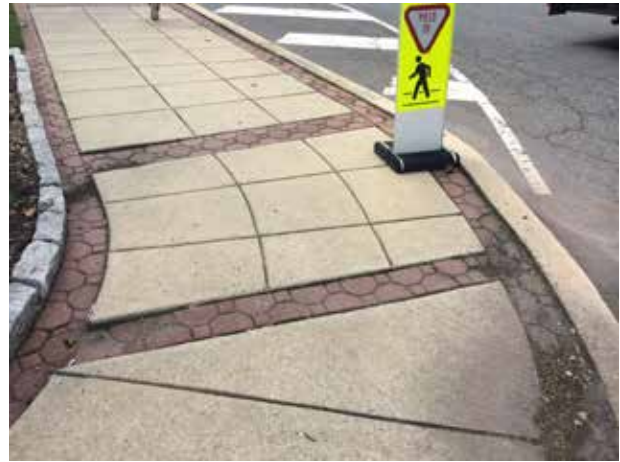
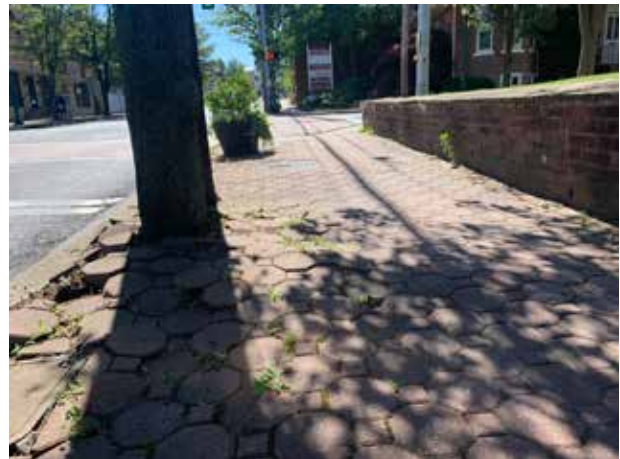
Some sections of pavers along Main Street are in disrepair. Many pavers are sunken between blocks of concrete or are broken causing an uneven sidewalk

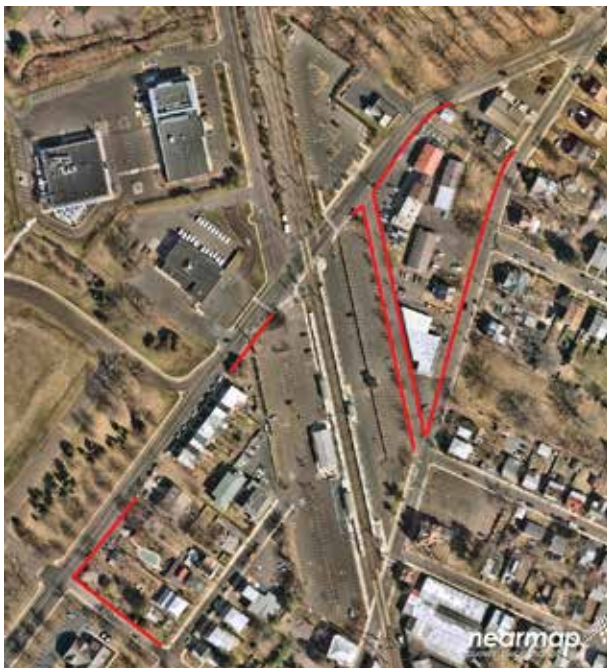
Many sidewalks are missing around the train station- they are noted in red.

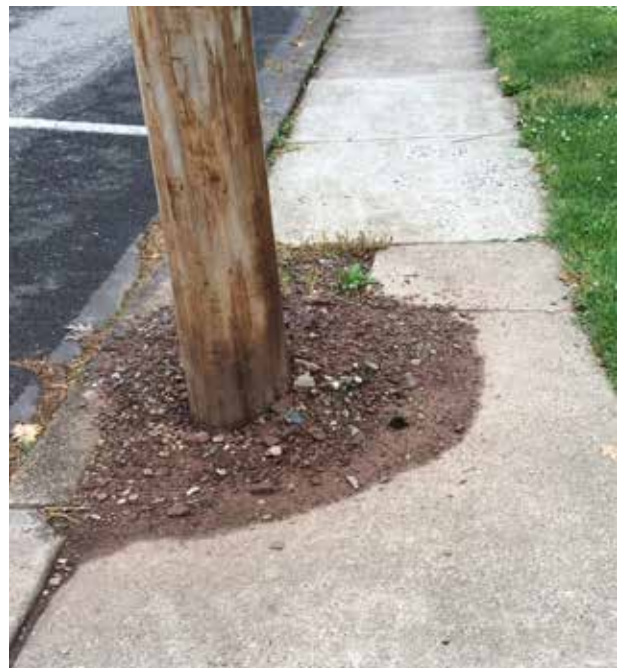
Obstructions in the sidewalk causes sidewalks to become quite narrow in many parts of the Borough, which is an accessibility issue. This issue is present on dozens of sidewalks throughout the Borough, so there is no one target area. The Borough should consider

Utility poles can obstruct sidewalks

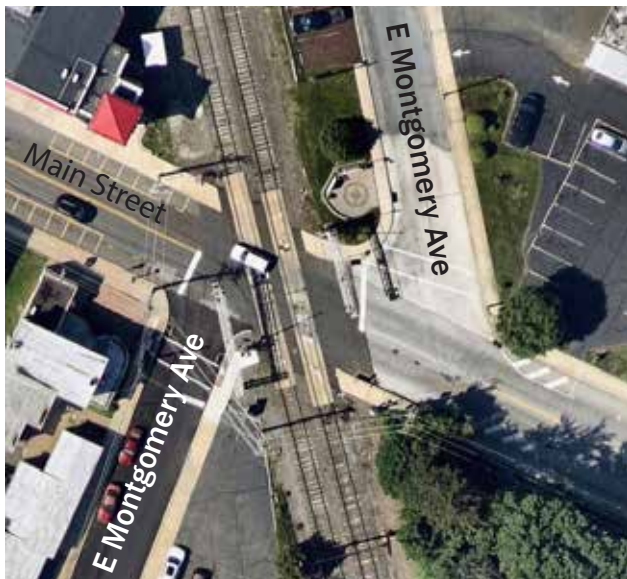
The intersection of Main Street and East Montgomery Avenue, pictured to the right, is a prime example of an area that may benefit from a curb bumpout. There are existing hatched areas on the north and south sides of the street, where cars should not be driving currently, which are in the exact locations where formal bumpouts could be built. Bumpouts can simply be concrete or be more ornate with brick pavers and may include low-growing landscaping; pedestrian

The intersections of Main Street with East and West Montgomery Avenues. NearMap, June 5, 2021.

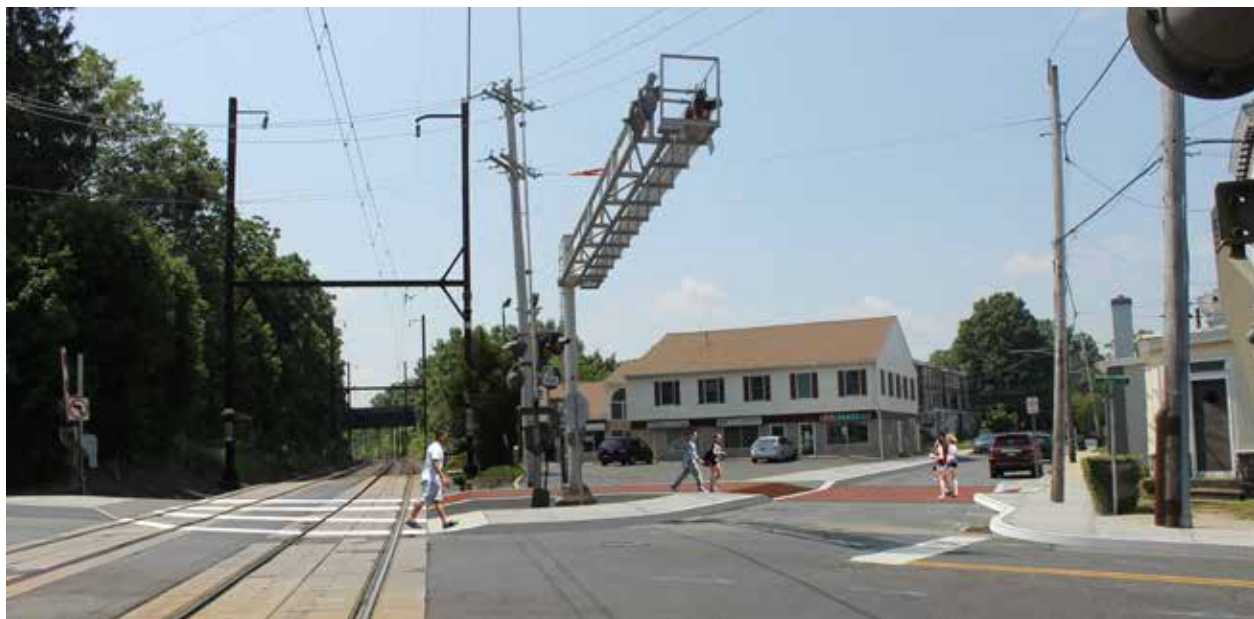
Rendering of the proposed improvements along the south side of Main St and W Montgomery Ave

below, or a standard concrete sidewalk. In addition to this, simple paint striping across where the sidewalk continues across the tracks would be highly beneficial. This would show a pedestrian that they are (a) allowed to walk across the tracks and (b) where they should walk. The asphalt or concrete in the designated pedestrian crossing area should be well-maintained and come as close to the tracks as possible to reduce tripping hazards.

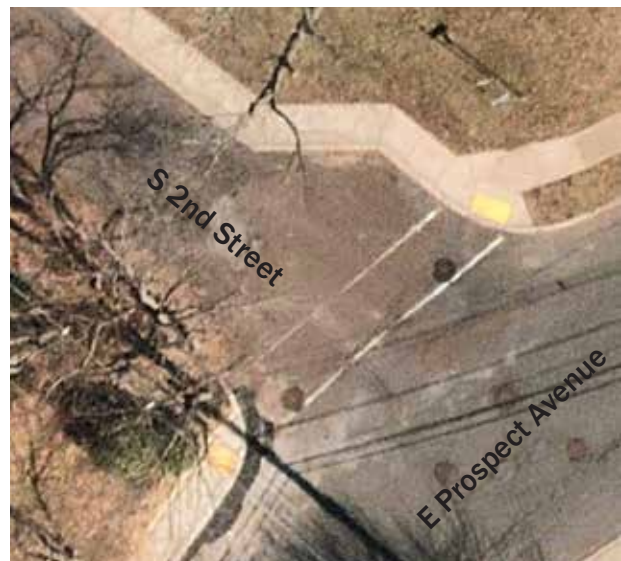
Source: NearMap, March 5, 2021

This intersection has a unique setup, as there is a curve on the north side of 2nd Street (which is a one-way street going east-west for this block) that makes for a wider street and turning path for vehicles. The south side of the intersection has a similarly wide turning area. Due to these factors, the crosswalk is several feet longer than it would be for a typical one-way street intersection; therefore, a high-visibility crosswalk is recommended. In addition to this, the ramp on the south side of the intersection should be enlarged to make it safer. There are no sidewalks along the south side of 2nd Street nor along the east side of Prospect Avenue in

this area, which means there is currently no need for ramps or crosswalks across East Prospect Avenue. The construction of sidewalks are advisable along Prospect Avenue and, potentially, along 2nd Street if there is adequate width in the right-of-way.

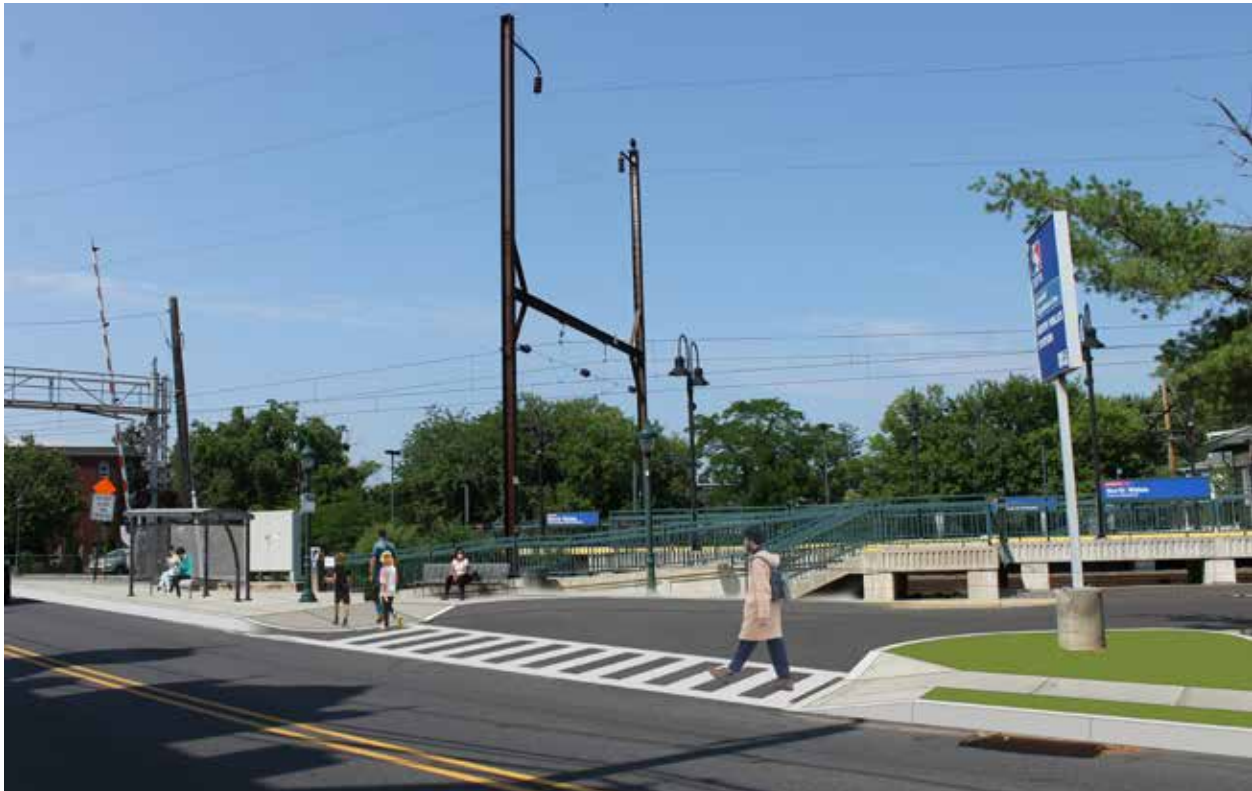
Rendering of the proposed improvements to the North Wales Train Station along Walnut Street

6<sup>th</sup> Street (AKA Railroad Street) lacks a sidewalk on both sides. Sidewalks should be added and a crosswalk should connect the south and north sides of the intersection with Walnut Street.
